3. EVALUATION OF OU 3-14 CONTRIBUTING SOURCES

3.1 OU 3-14 Soil Contamination Sites

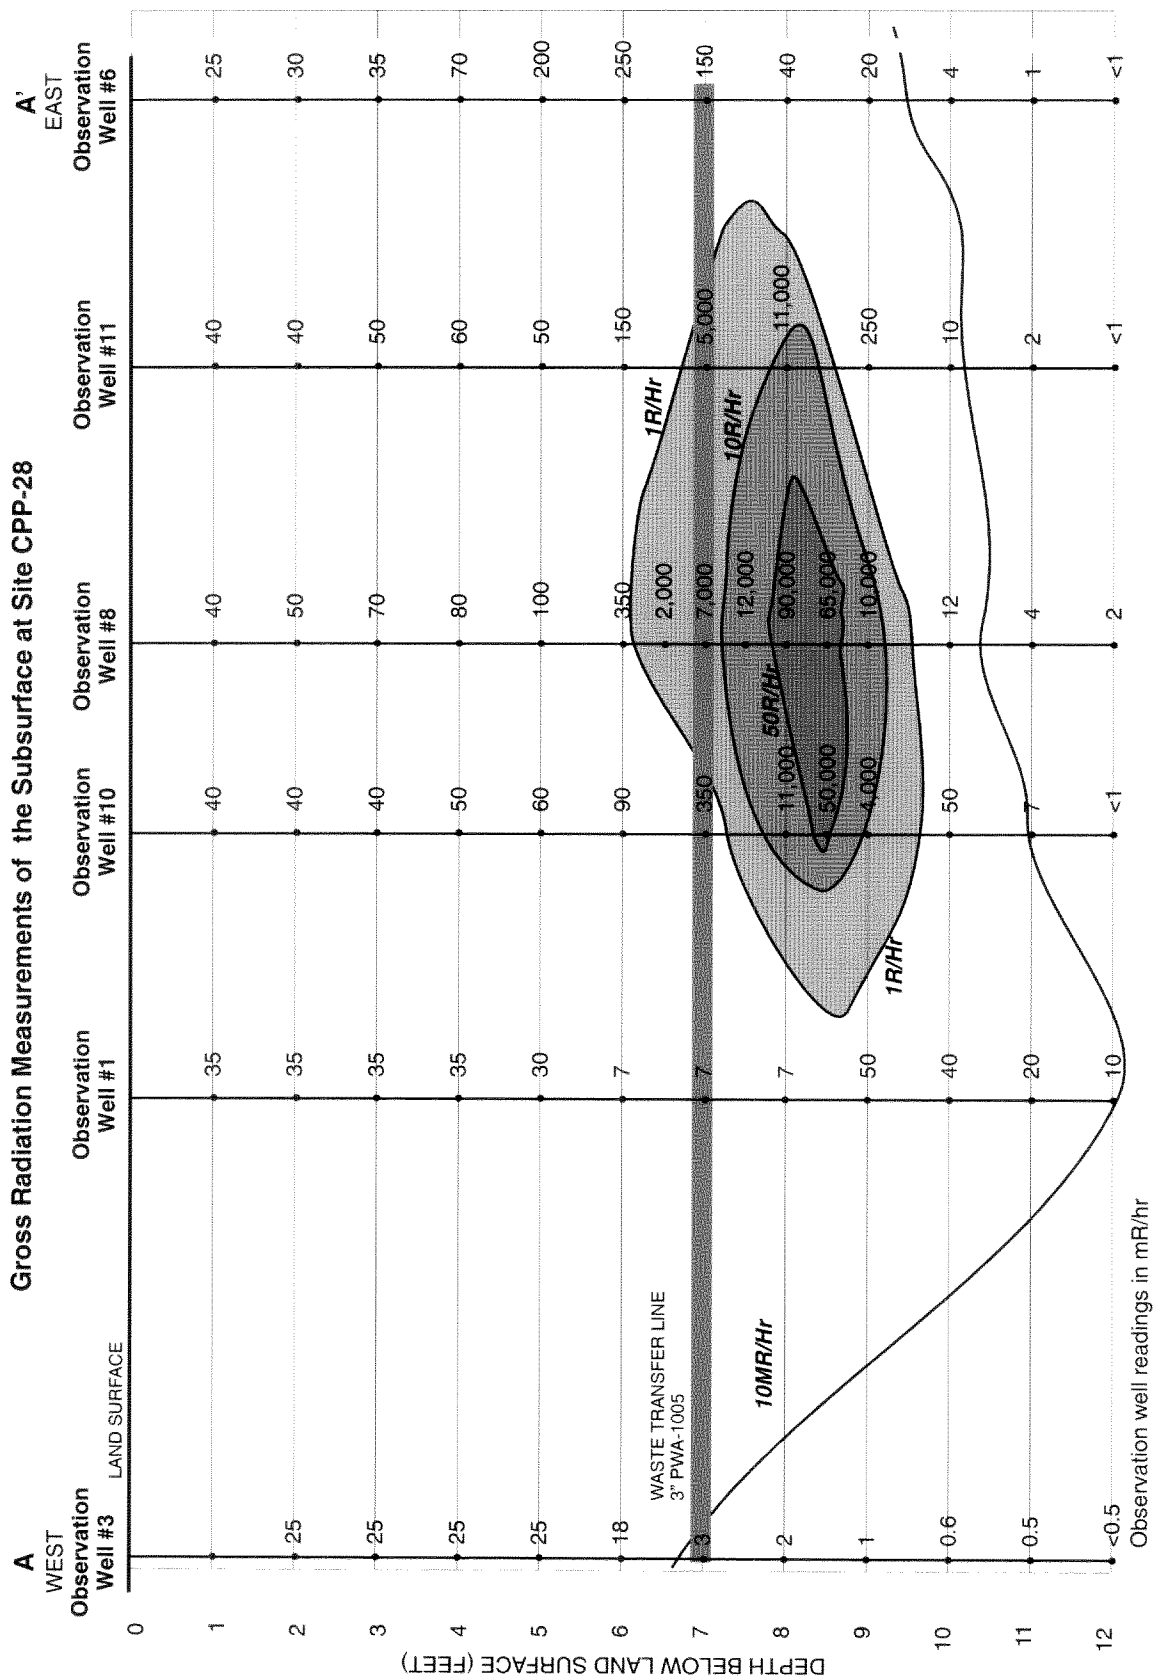
Figure 3-16. East-west fence diagram through the contaminated soil zone at CPP-28.

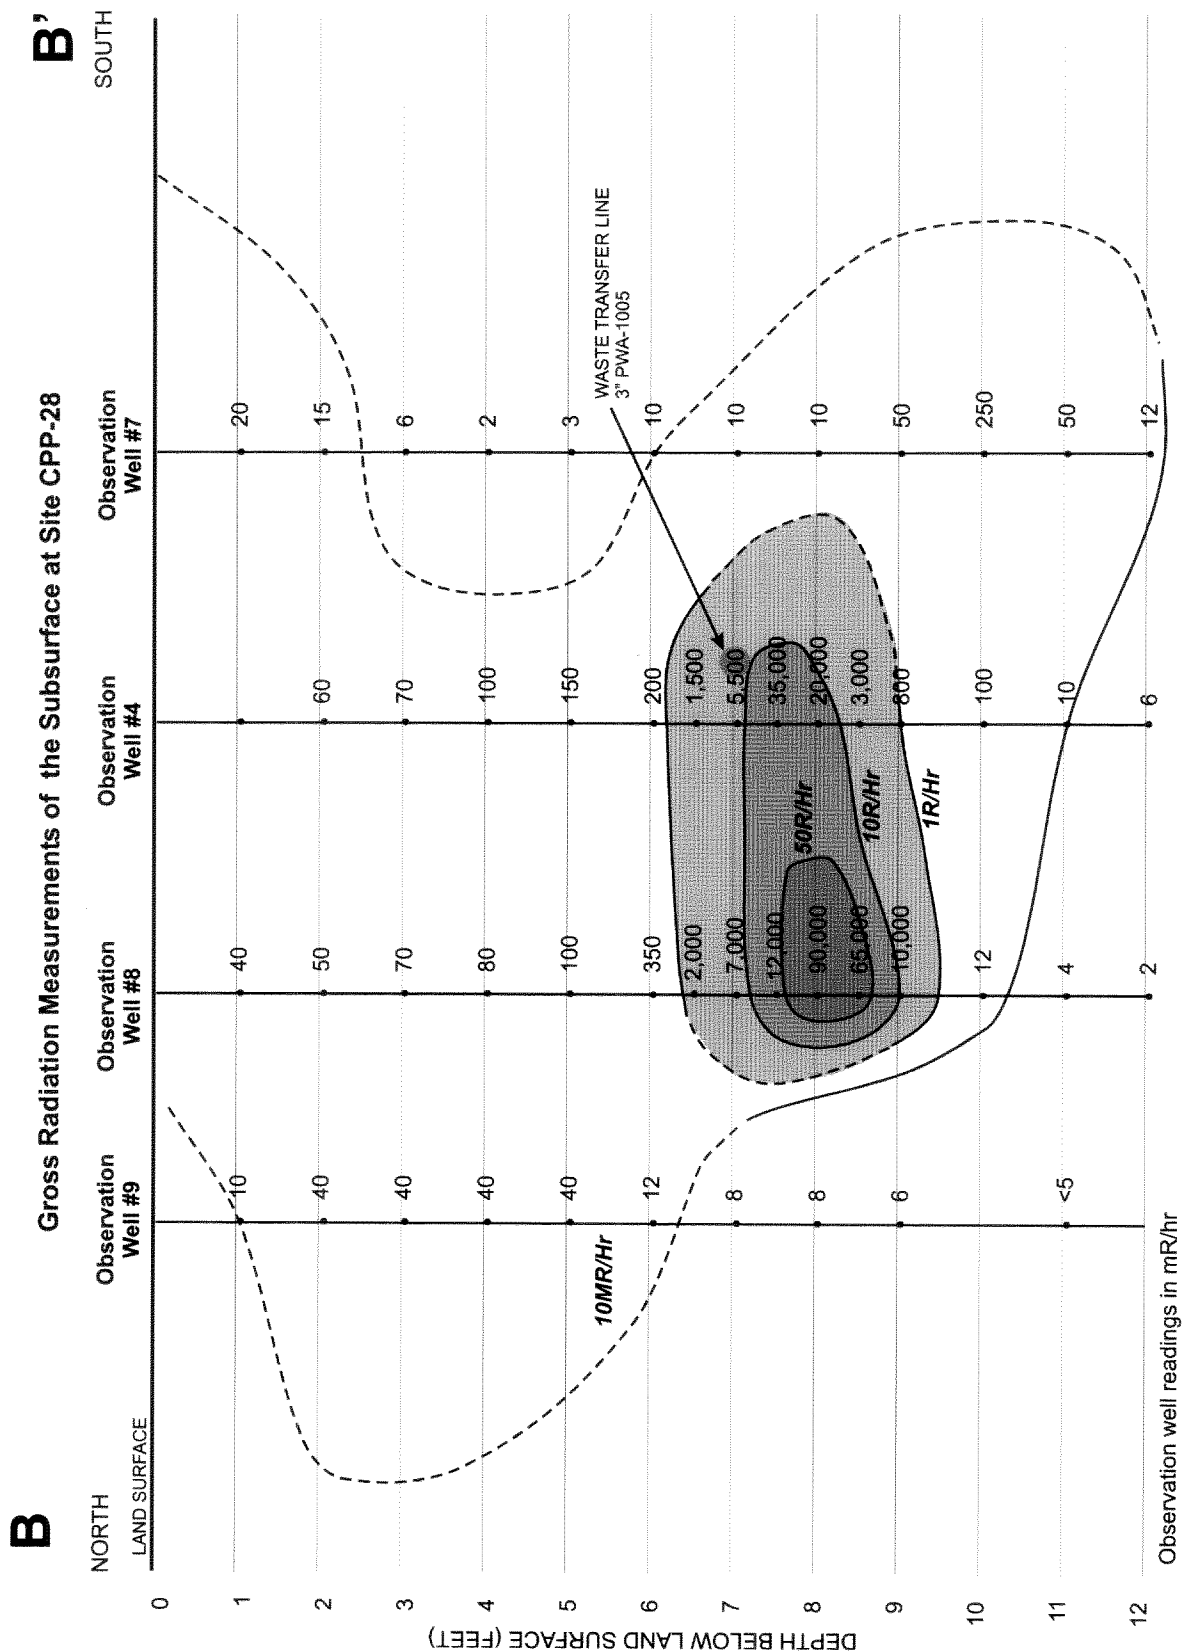
Figure 3-17. North-south fence diagram through the contaminated soil zone at CPP-28.
